**Application of Plasma Arc (PAV) Vitrification to Improve Stability of Weak Soil
and Weathered Rock**

1. Report No. FHWA/NC/2002-014	2. Government Accession No.	3. Recipient's Catalog No.	
4. Title and Subtitle Application of Plasma Arc Vitrification (PAV) to Improve Stability of Weak Soil and Weathered Rock		5. Report Date August 2001

14. Sponsoring Agency Code HWY-0860	
15. Supplementary Notes			
16. Abstract A slope failure along US-1, South, near Apex, North Carolina is utilized as a case study for the application of Plasma Arc Vitrification (PAV) as a soil improvement technique. The project work encompassed in situ and laboratory characterization of the site soils, laboratory burn of site soils, as well as slope stability computer analysis. Field exploration of the slope material was performed by conducting traditional standard penetration testing (SPT) and extensive geophysical testing. Samples were collected during the drilling for laboratory classification of the material as well as measurement of site soils' strength properties. Furthermore, inclinometers were installed at the site to assess the location of the possible slip plane and the possibility of further movement

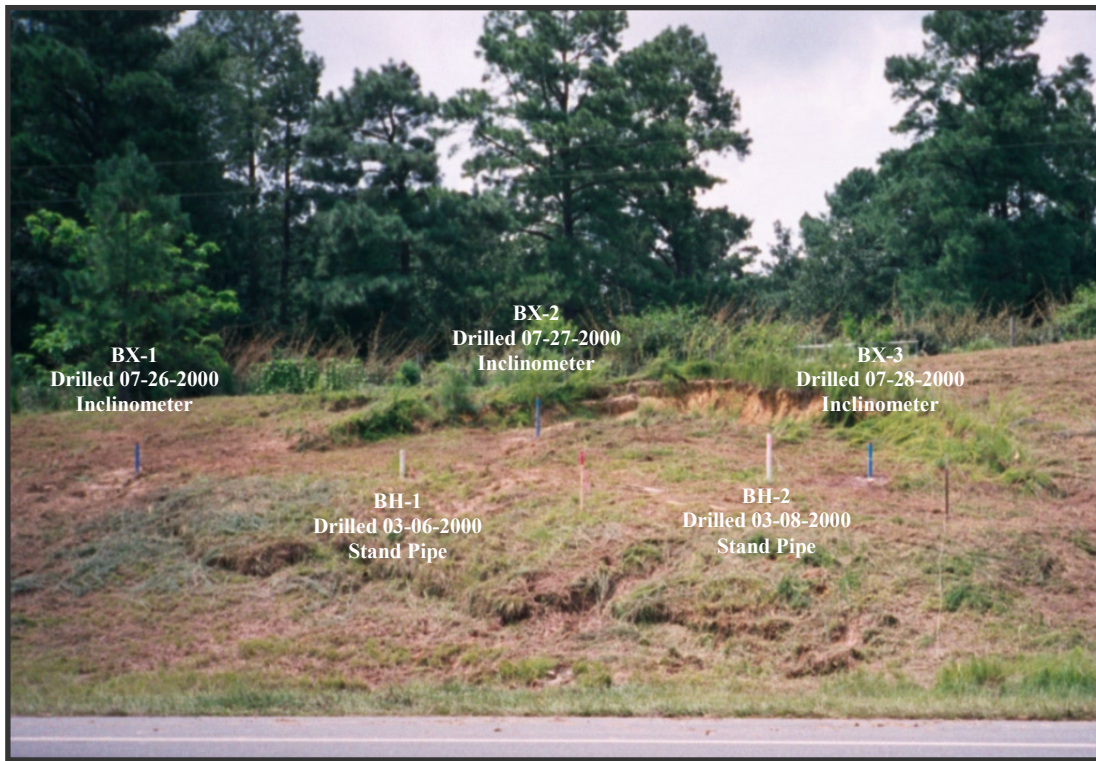
Figure 29. US Route 1 Borehole Locations

The NCDOT Geotechnical Unit conducted subsurface investigations and inclinometer installation activities at the site during the months of March and July 2000. The subsurface investigation consisted of a total of five soil test borings. Standard penetration tests (SPT) and soil sampling were performed at each of the borings. Figure 29 shows locations, dates, and type of instrumentation installed at the slope site.

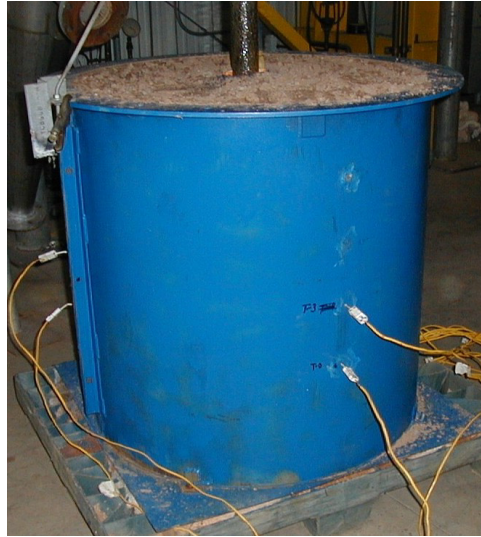
Figure 37. Photograph of Test Chamber Setup (Georgia Tech, 2001)

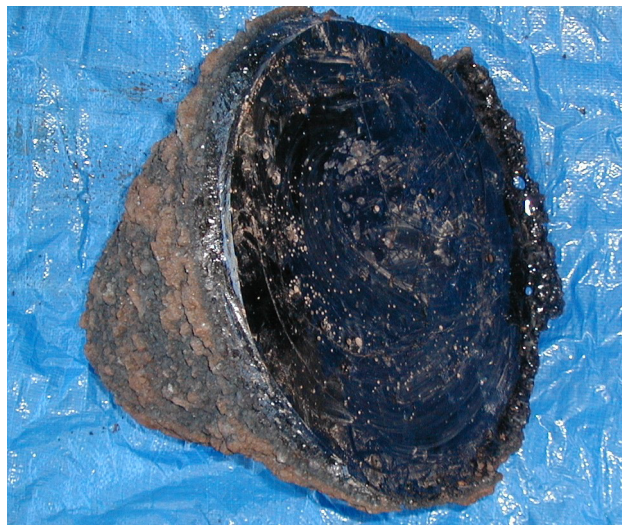
Figure 38. Vitrified Column of Weathered Mudstone Created using 100-kW Torch
(Georgia Tech, 2001)

After the test completion, magma was allowed to cool for 48 hours before opening the chamber. No significant subsidence was observed. Originally, the mass of the soil was 2041.5 lbs. After vitrification, the total mass of the vitrified and unvitrified soil dropped to 1993.0 lbs. The weight loss could be attributed to drying of the soil surrounding the vitrified zone. The vitrified column weighed 103.6 lbs. Figure 38 shows a photograph of the vitrified end product.

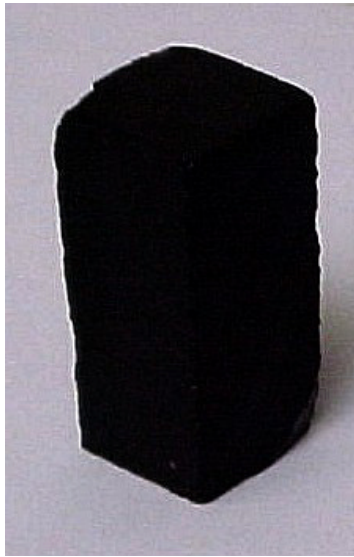
Figure 40. Photograph of the Vitrified US 1 Clay Compression Test Specimen
(Georgia Tech, 2001)

The compressive strength of the cooled rock-like product was measured by a uniaxial compression test using a SATEC compression machine, at Georgia Institute of Technology. The specimen was loaded at a constant rate of 0.2-in/minute. A sample was trimmed, using a diamond saw, into a cube 0.7 in X 0.7 in X 1.5 in and the loading faces were cut parallel. Specimen is shown in Figure 40. The sample started shattering but did not completely fail when the compression machine capacity was reached. The peak load was 15.1 kips. Accordingly, the compressive strength would be higher than 4845.6 ksf or 33.65 ksi. The stress-strain curve is shown in Figure 41.

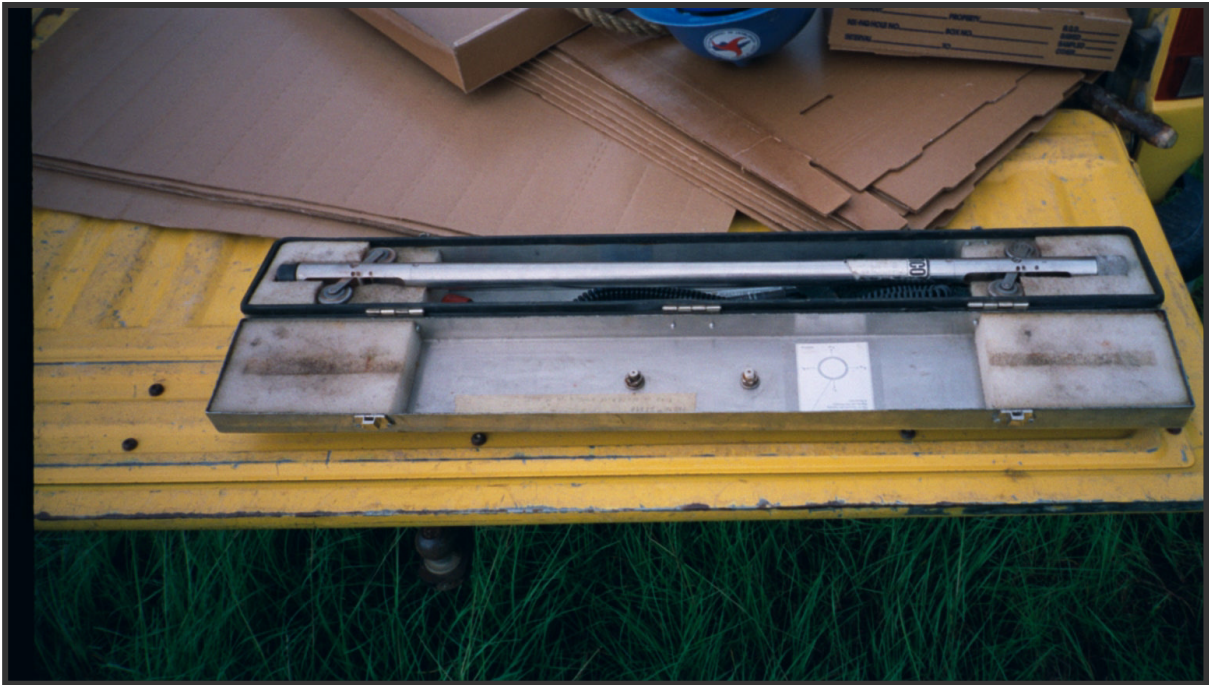
Figure C1: Inclinometer Probe

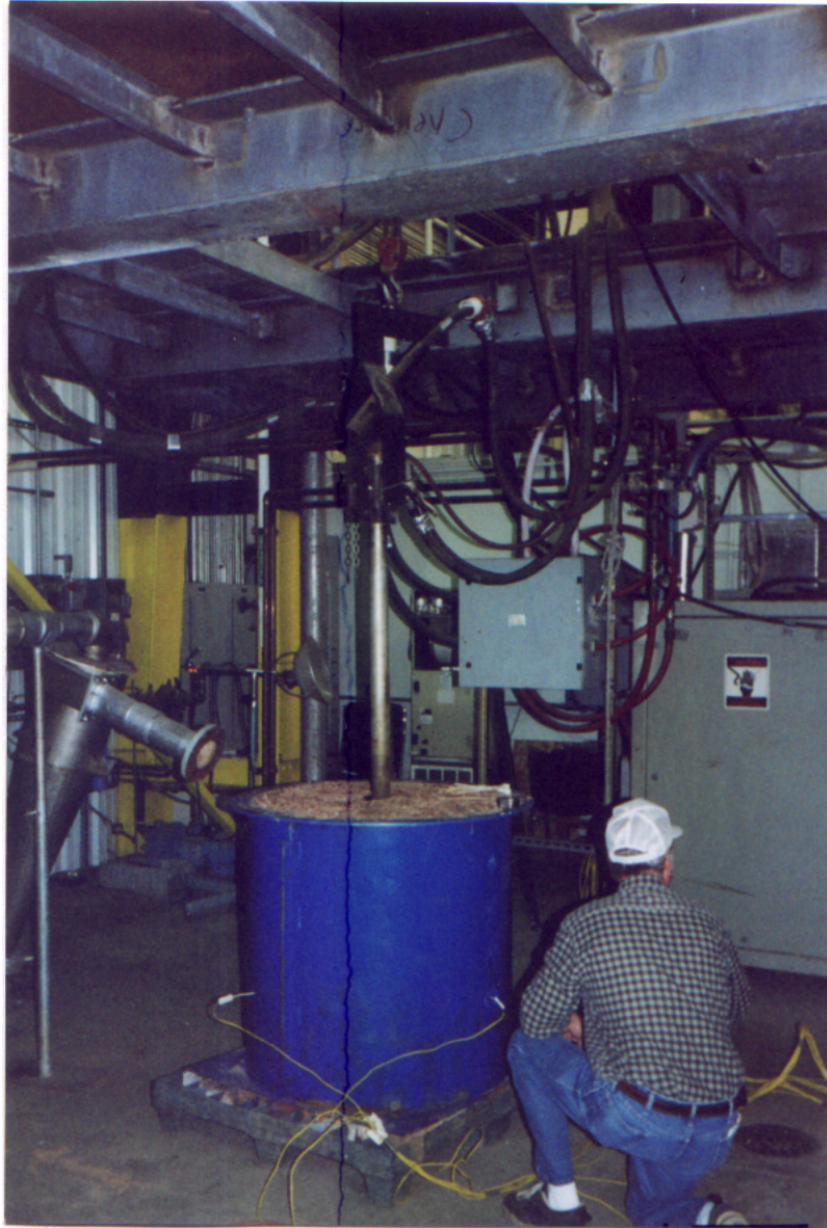
Figure D1. Laboratory Vitrification Setup

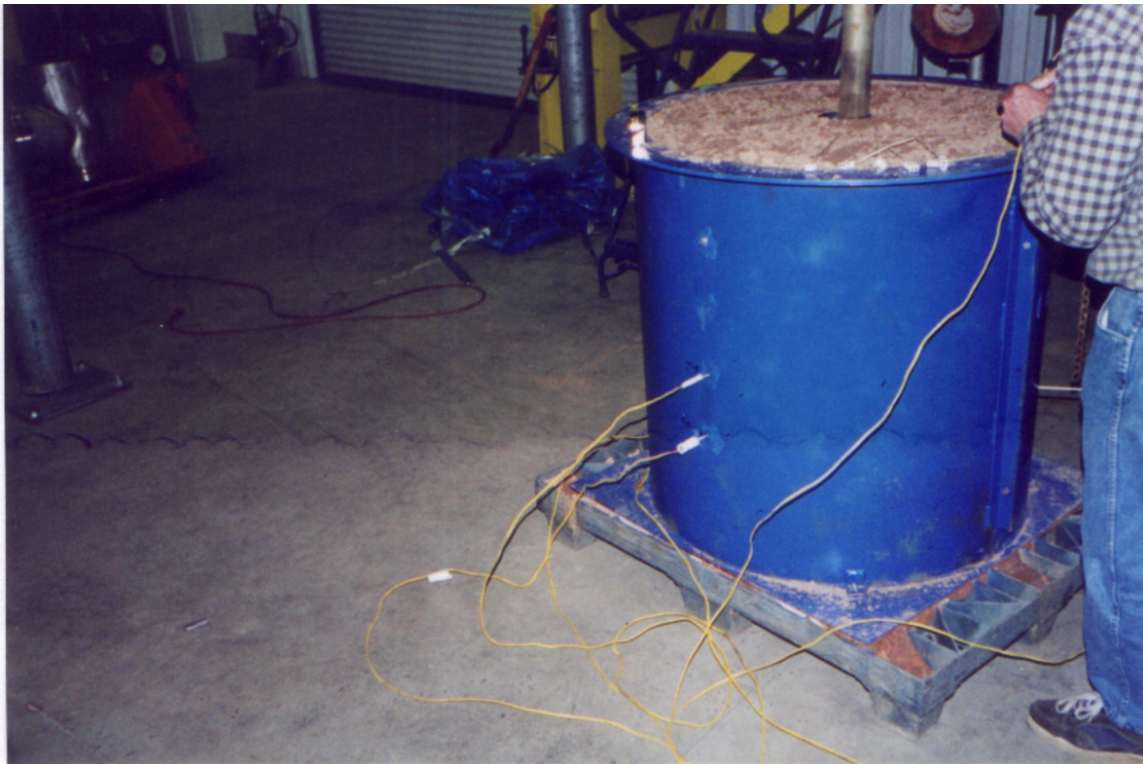
Figure D2. Chamber Set-up

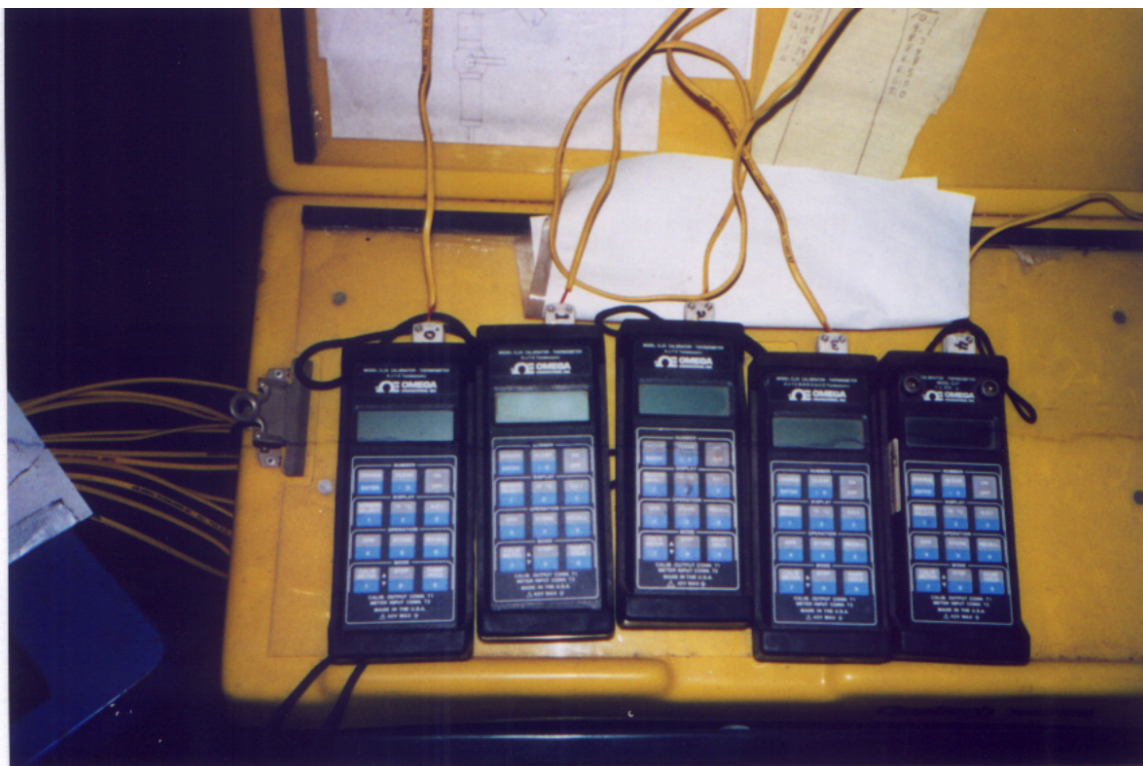
Figure D3. Setting the thermocouples

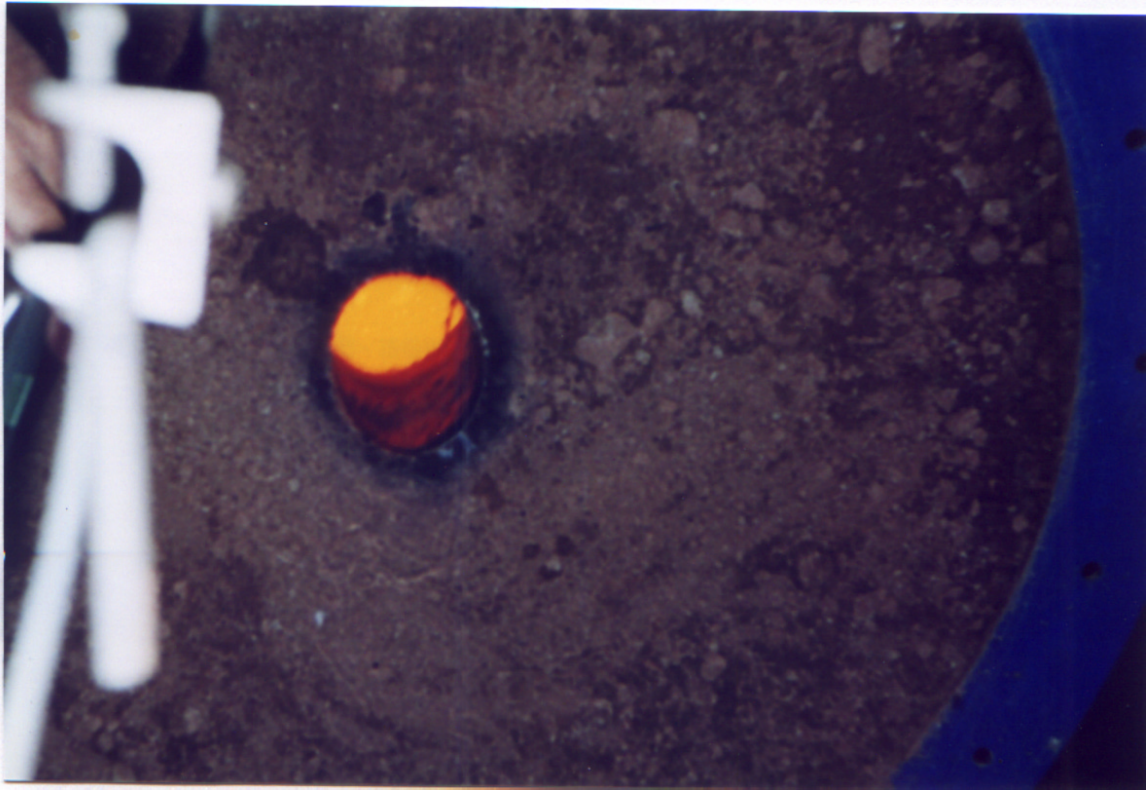
Figure D8. Vitrified material
